SEISMIC ASSESSMENT OF SCHOOL BUILDING IN SRI LANKA USING FRAGILITY CURVES

K. A. T. M. Abey Siriwardena , R. M. A. Buddika and K. K. Wijesundara

Department of Civil Engineering, University of Peradeniya, Sri Lanka
malingathari@gmail.com

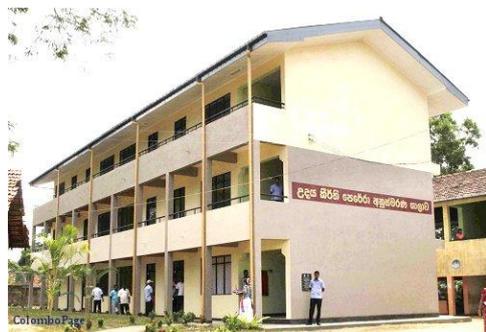
Figure 1: Selected typical school building

The selected school building is a three story reinforced concrete frame structure as shown in Figure 1: Selected typical school building, Typical gravity design school building's performance under an earthquake is assessed in this study. First all the elements were modelled using OPENSEES finite element software for analyse the structure for static pushover and time history analysis in a 3D right hand Cartesian coordinate system. In order to develop fragility curves, limit drift values of immediate occupancy and collapse prevention performance levels were obtained by pushover analysis. Next, time history analysis was performed to estimate the mean and

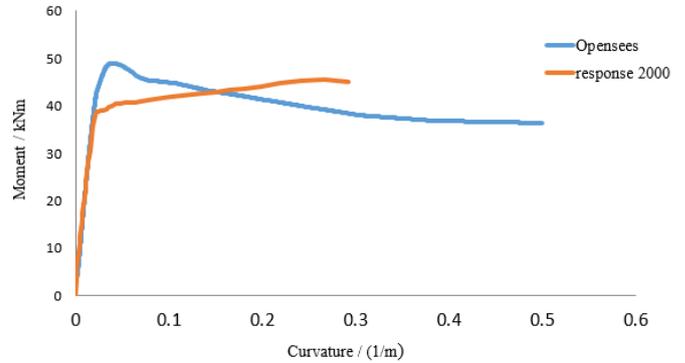
Figure 2: Moment-Curvature comparison of OpenSees and response2000 beam 39 section

Ultimate moment capacity obtained by OpenSees software and Response2000 of beam 39 is almost similar. In Response2000 software applies a fixed axial force for this analysis while in OpenSees software the beam is subjected to a variable axial force. But considering the ultimate moment capacity, the results obtained by OpenSees software is accurate.

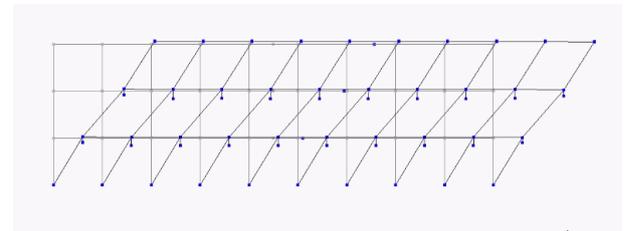
Figure 3: Deformed shape of the model due to triangular force distribution

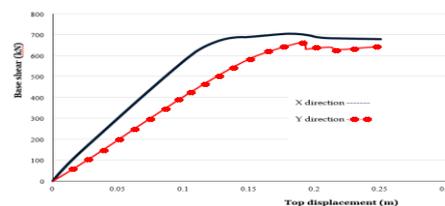
Figure 5: Pushover curves

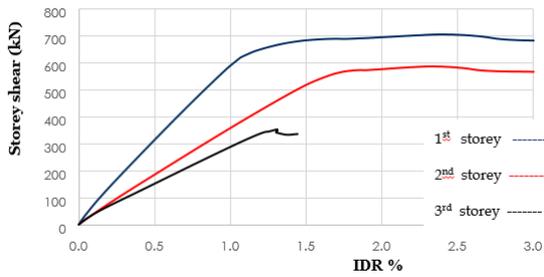
Figure 6: Story shear vs IDR% in longitudinal direction

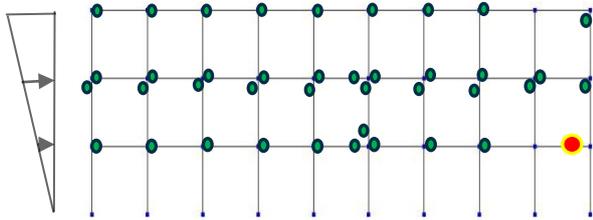
Figure 7: Plastic hinge formation in longitudinal direction

20% drop of moment of the member is considered as the failure of that element. Failure of one element can lead to collapse of whole building. Therefore, using the moment curvature diagrams of critical elements, load step corresponding to failure of that elements can be identify. Having found the critical load step for both x and y direction, collapse prevention performance level can be identified in the 1st storey pushover curve.

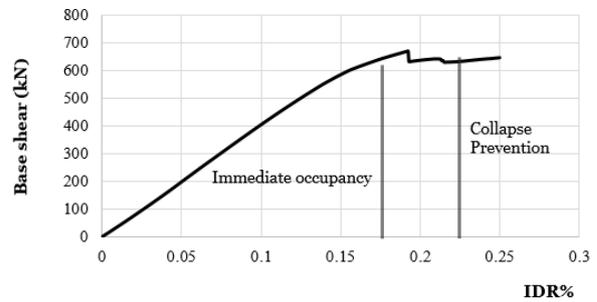
Figure 9: Performance level limits in Y direction

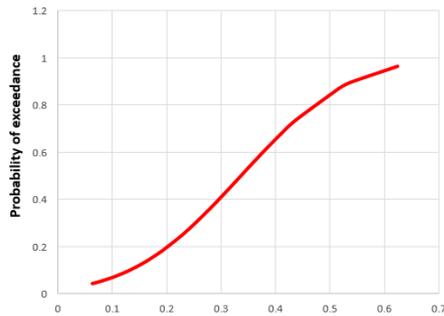
Figure 12: Fragility curve for collapse prevention performance level

According to past studies, the expected PGA value for Sri Lanka is 0.15g. It is observed from the fragility curves that three storey 12 class room type plan school building displays 58% probability to building to get damage under an earthquake of PGA of 0.15g. And there is less than 10% of probability to get the building completely collapse under the level of PGA of 0.15g.

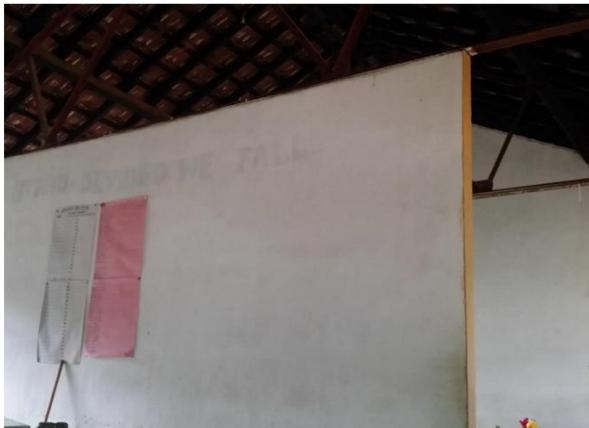
Figure 13: Walls with low flexural strength inside the building

Furthermore, it is important to highlight that some of the non-structural walls which have been used to separate class rooms are unconfined masonry infill walls there for it is strongly recommended that confine that masonry infill walls in order to prevent collapse due to the out of plane response of the masonry walls. By introducing a section with higher moment capacity for longitudinal beams but less than the moment capacity of
