ANALYSIS OF THE MEELIYADDA BRIDGE FAILURE IN KURUNEGALA

ABSTRACT

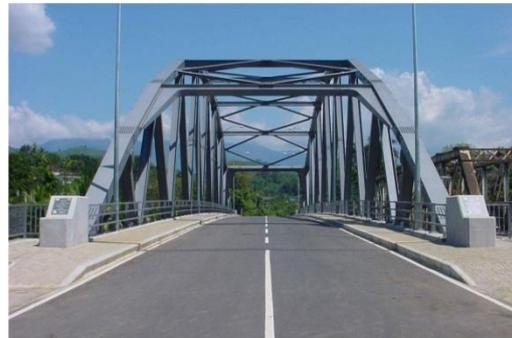
Figure 1: Muwagama Steel Bridge [1]

Truss type steel bridges can be classified into different types according to the structural systems. Warren, Pratt and Howe are some of the basic truss types. Different truss types have come up later with some modifications to the basic truss types. Varied height truss types became popular with the aesthetical appearance and can be used for higher spans effectively. Warren, Pratt, Double warren and varied height truss are some of the common truss types used in Sri Lanka. Veralgastotupola Bridge, Muwagama Bridge, Nattupana Bridge are some recently built truss type steel bridges in Sri Lanka. Figure 1 shows the Muwagama Bridge located in Muwagama, Rathnapura.

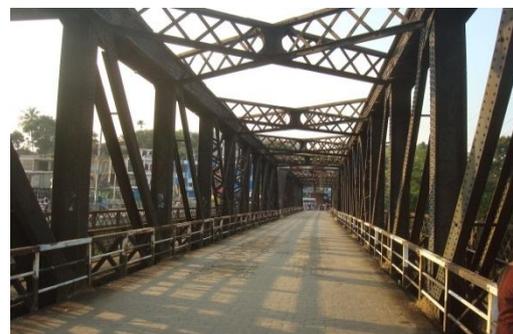
Figure 2: Gampola Steel Bridge

outdated for the modern traffic conditions, where the bridges such as Allawa Bridge, Gampola Brige and Katugasthota Bridge have been replaced with newer concrete/steel bridges. Figure 2 shows the old steel bridge located in Gampola [1].

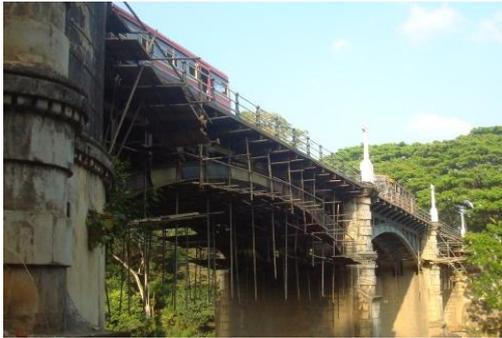
Figure 3: Peradeniya Steel bridge

However, some of the old truss type steel bridges such as Peradeniya Bridge, Kochchikade Bridge and Moratuwa Bridge are still on operation with the modern traffic. Figure 3 shows the steel truss bridge in Peradeniya. It is important to investigate the present condition and suitability of these existing bridges for the modern traffic as a bridge failure could be devastating causing damage to the vehicles and loss of human lives.

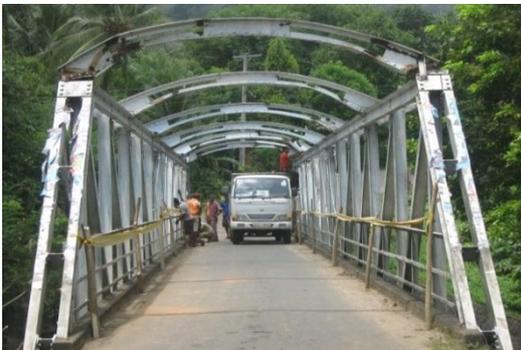
Figure 4: Meeliyadda Bridge before the failure

This paper investigates the failure of the Meeliyadda Bridge, which has been occurred recently, when two trucks carrying metal were crossing the bridge. A view of the Meeliyadda Bridge before the failure is shown in Figure 4, while a view of the failed bridge is shown in Figure 5.

The Meeliyadda Bridge was constructed in about 1820 by the British government in order to transport rubber to a nearby factory. The bridge was constructed across the Deduru Oya in the Miliyadda area on the road connecting Keppettigala and Kurunegala. This is a Pratt type truss bridge having a length of of 37.2m, width of 4.2m and height of 3.6m.

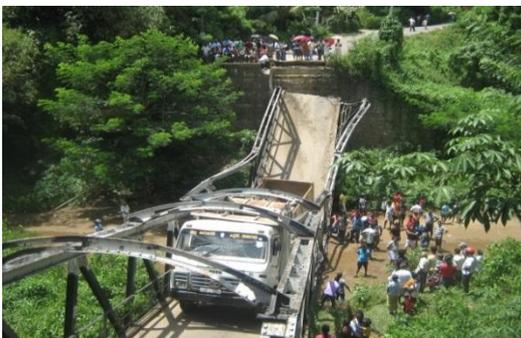
Figure 5: Meeliyadda Bridge after the failure

On 25th of July 2015 this bridge failed when 2 trucks carrying metal was crossing the bridge. It was evident from the villages that the lateral bracings to the top chord were subjected to corrosion and were also damaged time to time by

hitting the tippers crossing the bridge. However, exact cause for the failure was not known and hence it was studied in this paper.

The failure investigation of the Meeliyadda Bridge was carried out in this paper by using the SAP2000 FE software [2]. By observing the failed bridge it was identified that some of the lateral bracings to the top chord were removed during the failure. By observing the failed bridge and analyzing the information gathered from the villages, it can be predicted that the top lateral bracings would have been broken initially, which might be the reason for the bridge failure.

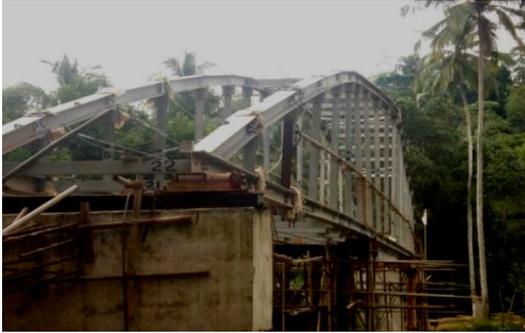
Figure 6: Ehelakanda Bridge Failure

Ehelakanda Bridge failed due to its self-weight while it was constructing in 2006. The reason for this failure was identified as the lateral torsional buckling of the top chord members close to the support. This was a pedestrian bridge where the lateral bracings could not be provided for the top chord members close to supports to meet the minimum headroom requirement of 2m.

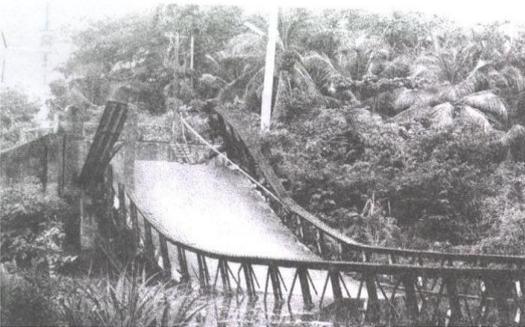
Figure 7: Paragasthota Bridge Failure

Paragasthota Bridge failed when a 10 wheel tipper with 5 cubes of metal (weight of about 20-25 tons) was crossing the bridge. The movement of the tipper towards the middle of the bridge increases the axial forces in both top and bottom chords. Results from a previous study [1] showed that the progressive collapse of the bridge was started with the tensile failure of a bottom chord member at the middle of the truss.
