ANALYSIS OF FIRST FLUSH OF ROOF RUNOFF AND WASH OFF PROCESS OF THE DIFFERENT ROOFING MATERIALS

Key words: First Flush, Wash-off Process, Different Roofing Materials

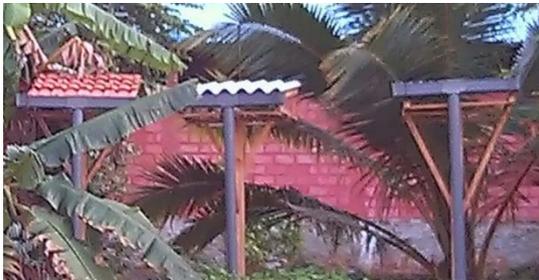
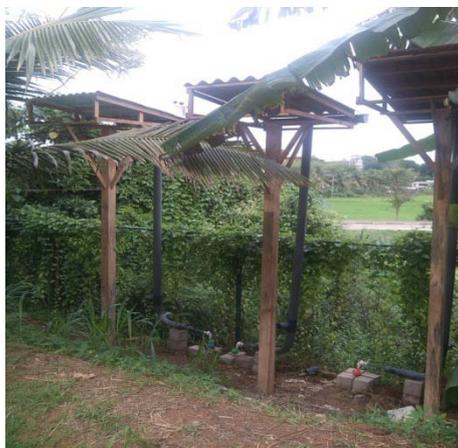
Figure 4: Final construction and arrangement of model roof in the field

Figure 4 shows the deployment of the model roofs in the field.
